Cachuma Project Water Rights Hearing

Panel V

Issues Related to Oak Trees, Sensitive Species, and
Recreation

Exhibit 245

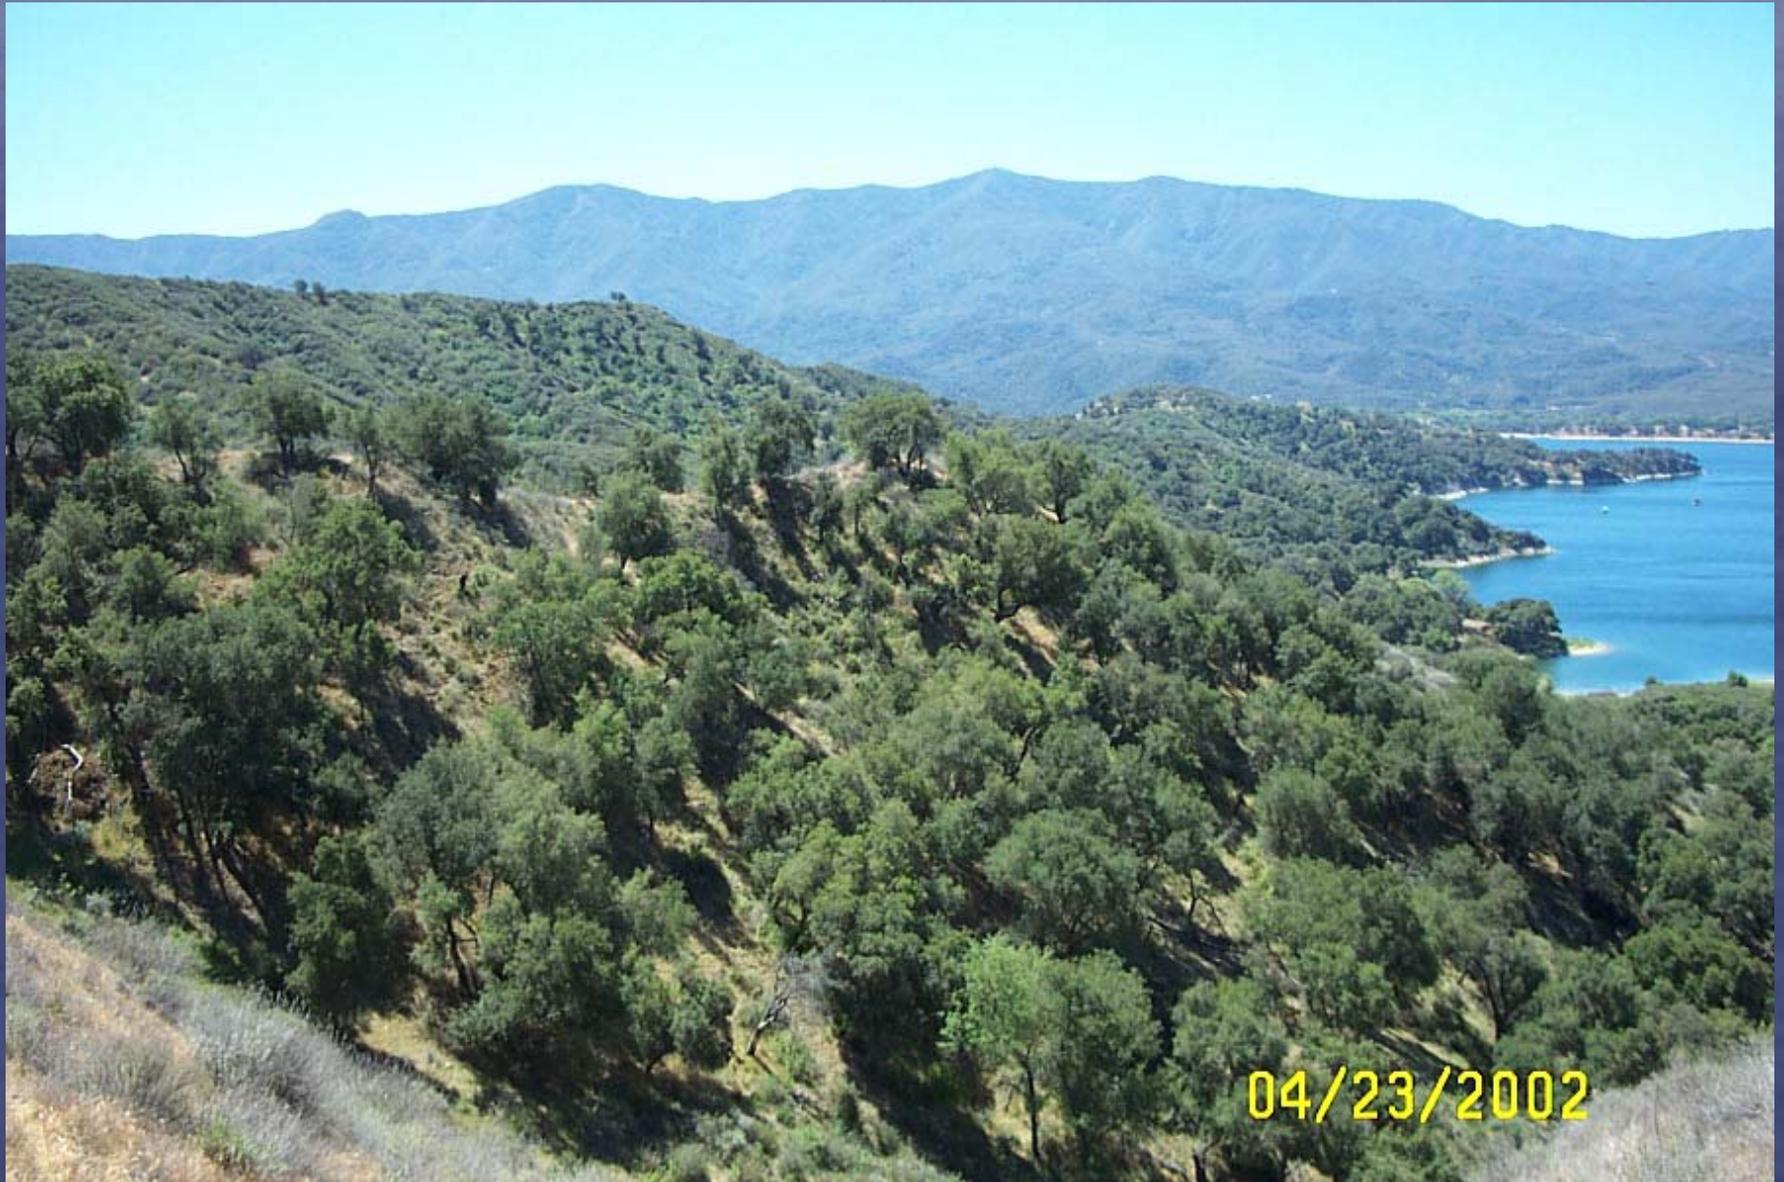
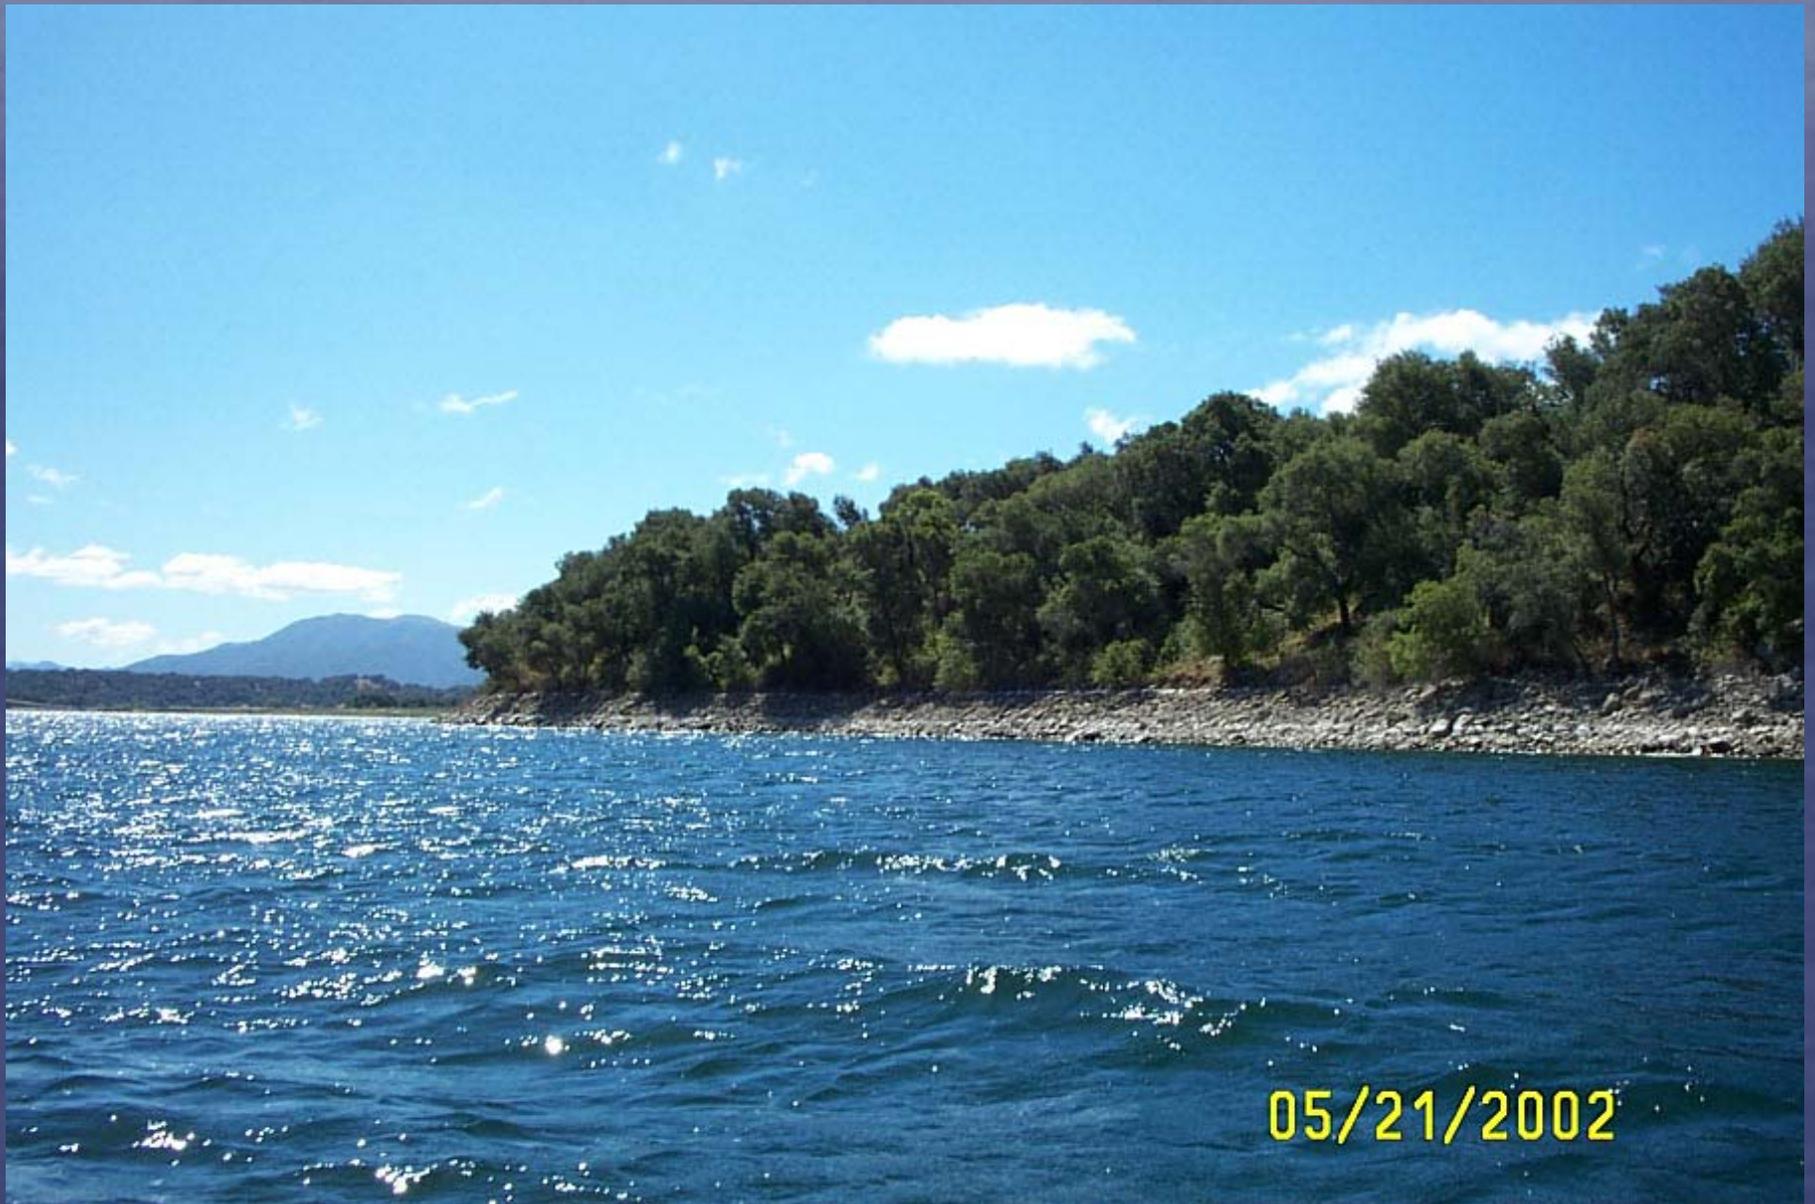
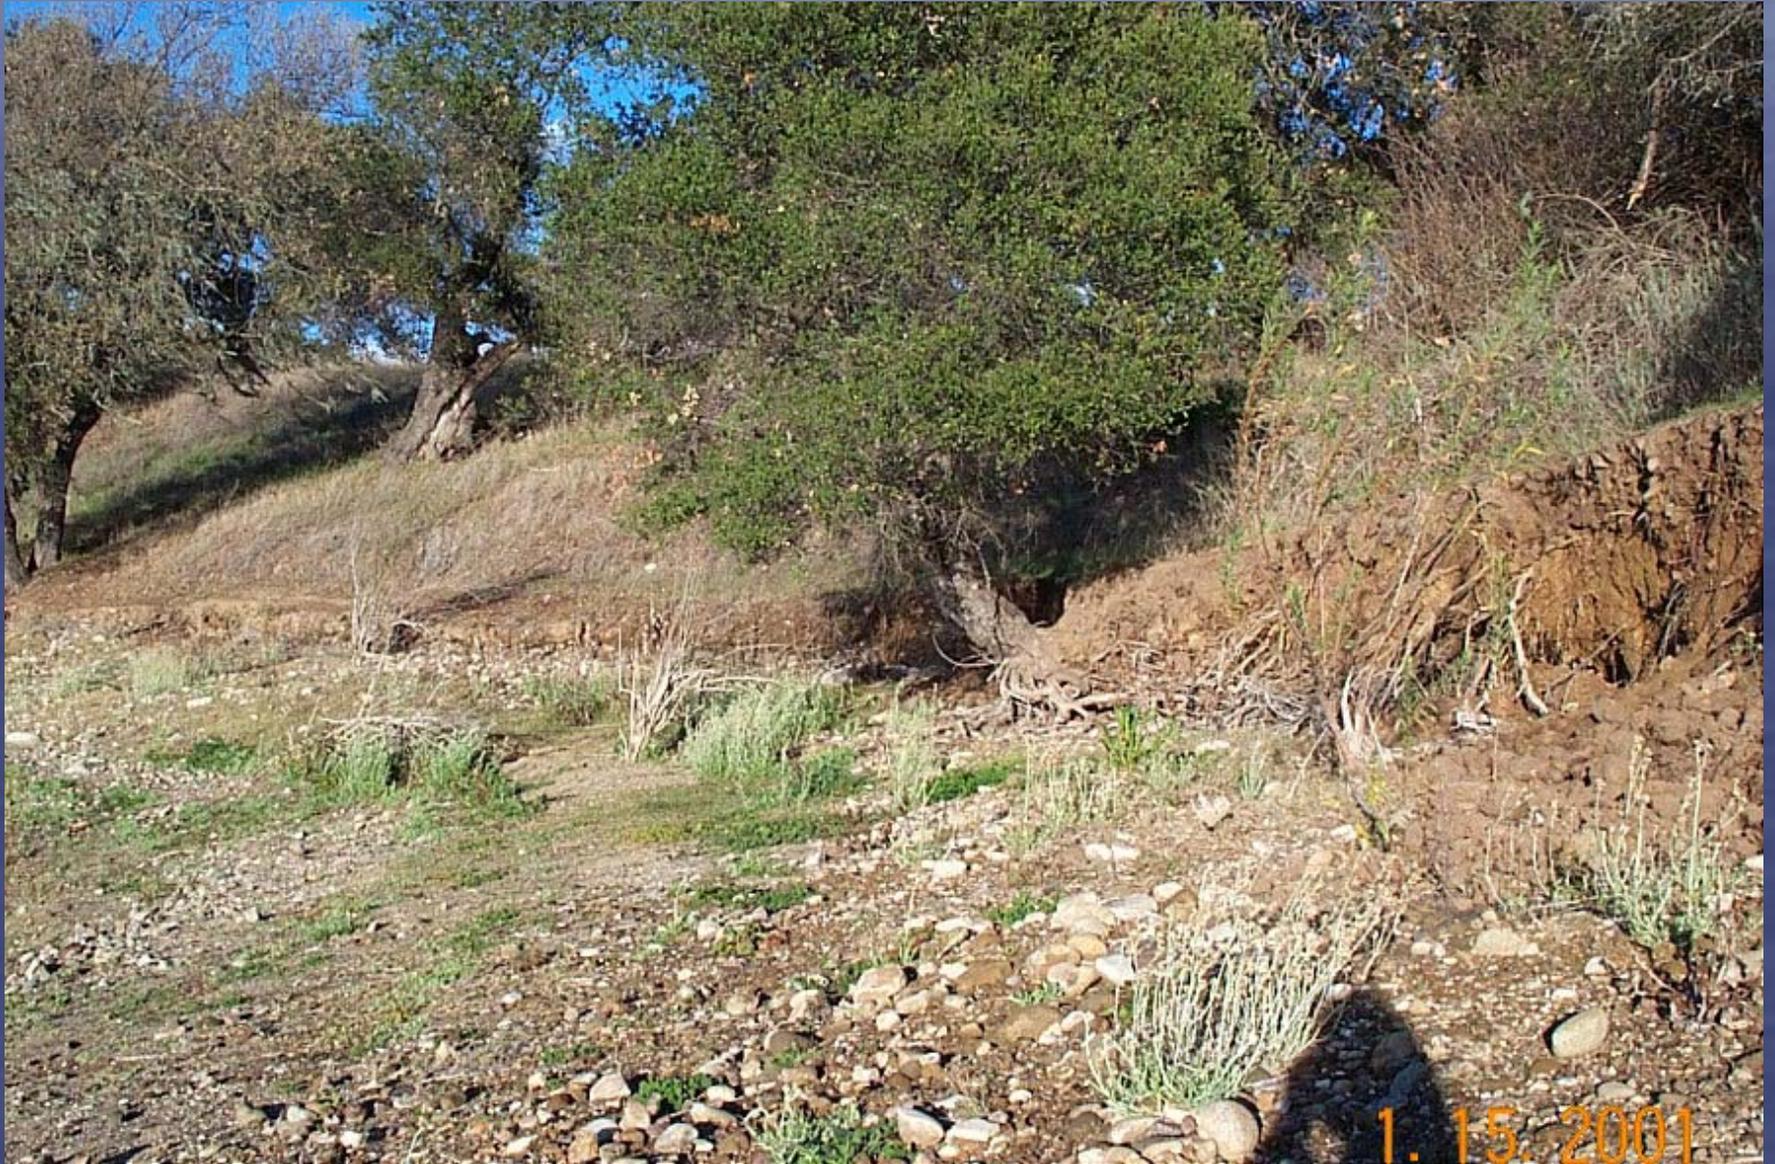
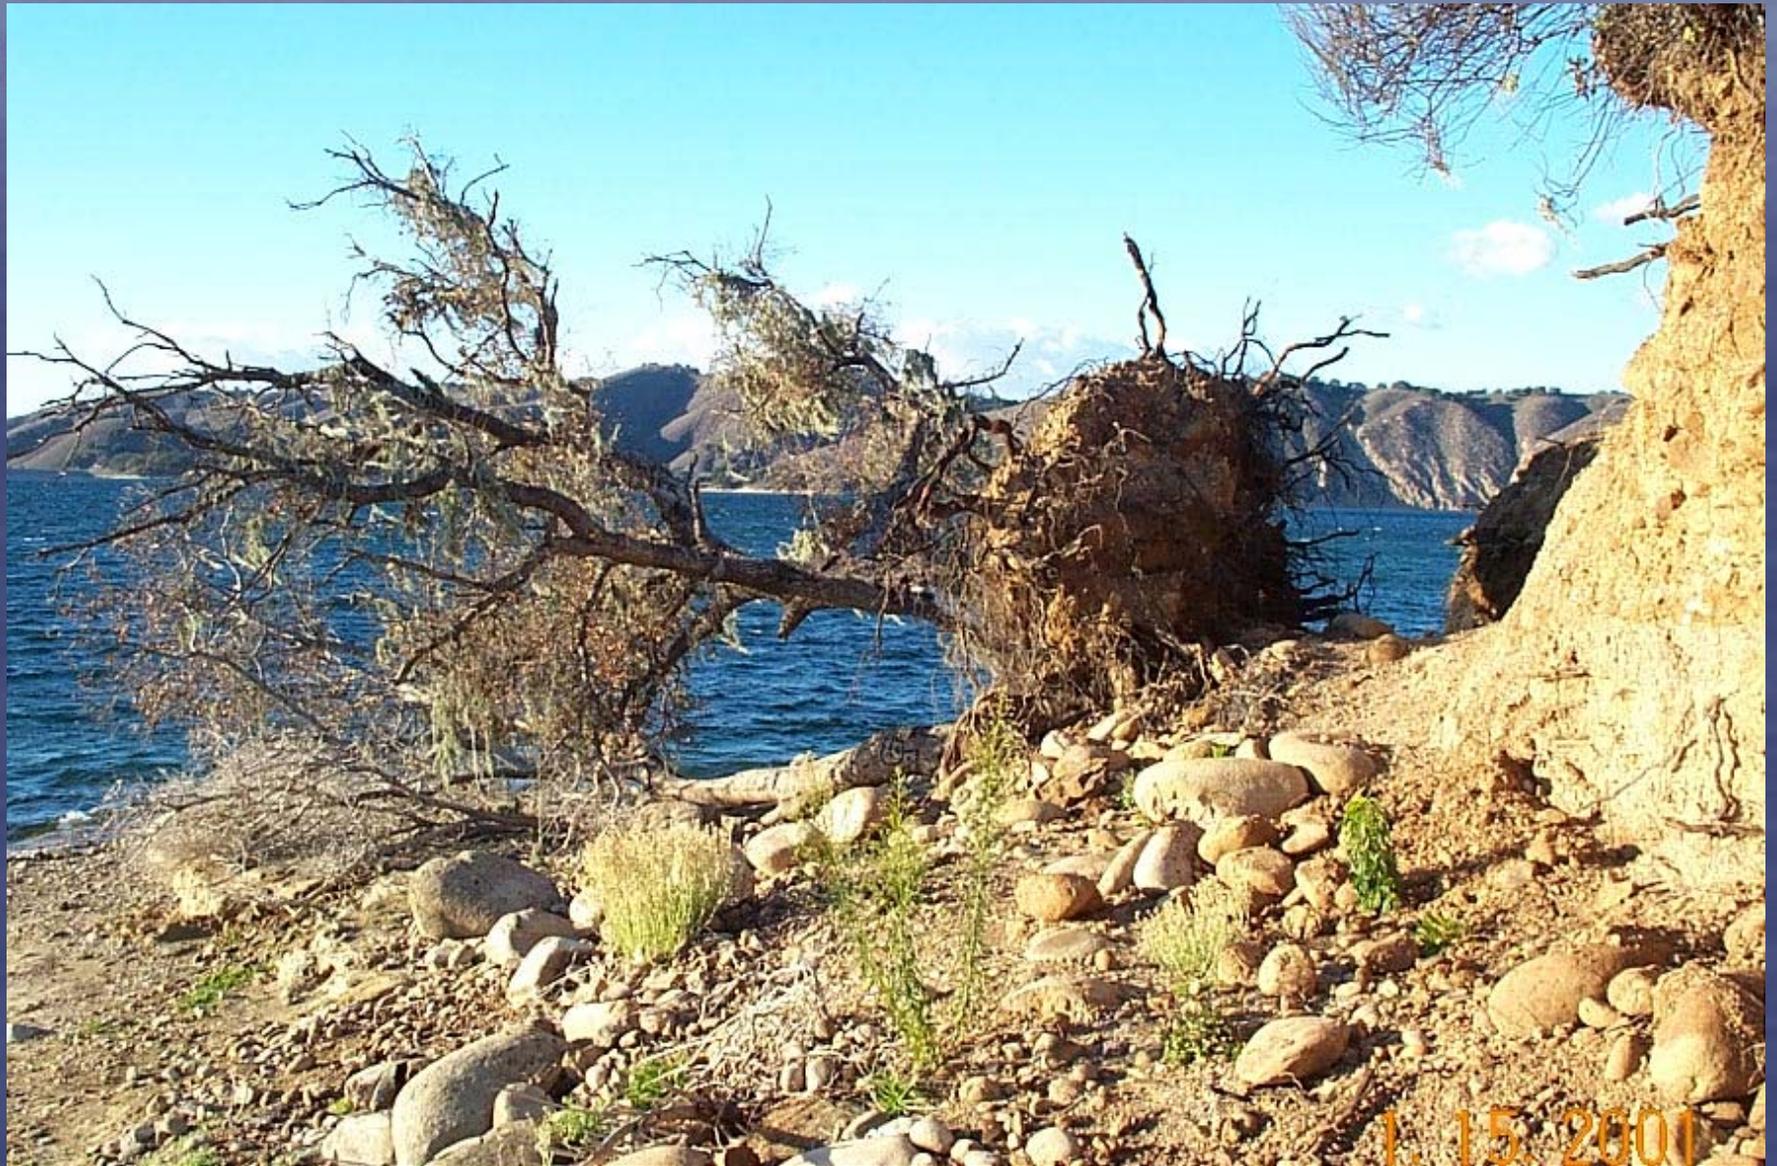
- Oak trees are abundant along the shoreline
- Field studies conducted to estimate oak trees in 3-foot inundation zone and in 3-foot wave action zone
- Essentially no trees in the current inundation zone due to losses over the past 50 years
- Only a small percentage dead or in poor health in wave action zone

- Most trees in the new inundation zone will be lost over time due to periodic inundation
 - Impact may require 20 years or more
 - 339 trees
- Only 25 % of trees in wave action zone expected to be adversely affected
 - 113 trees
- Total number of trees potentially affected:
 - 452 trees (412 coast live oak, 40 valley oak)

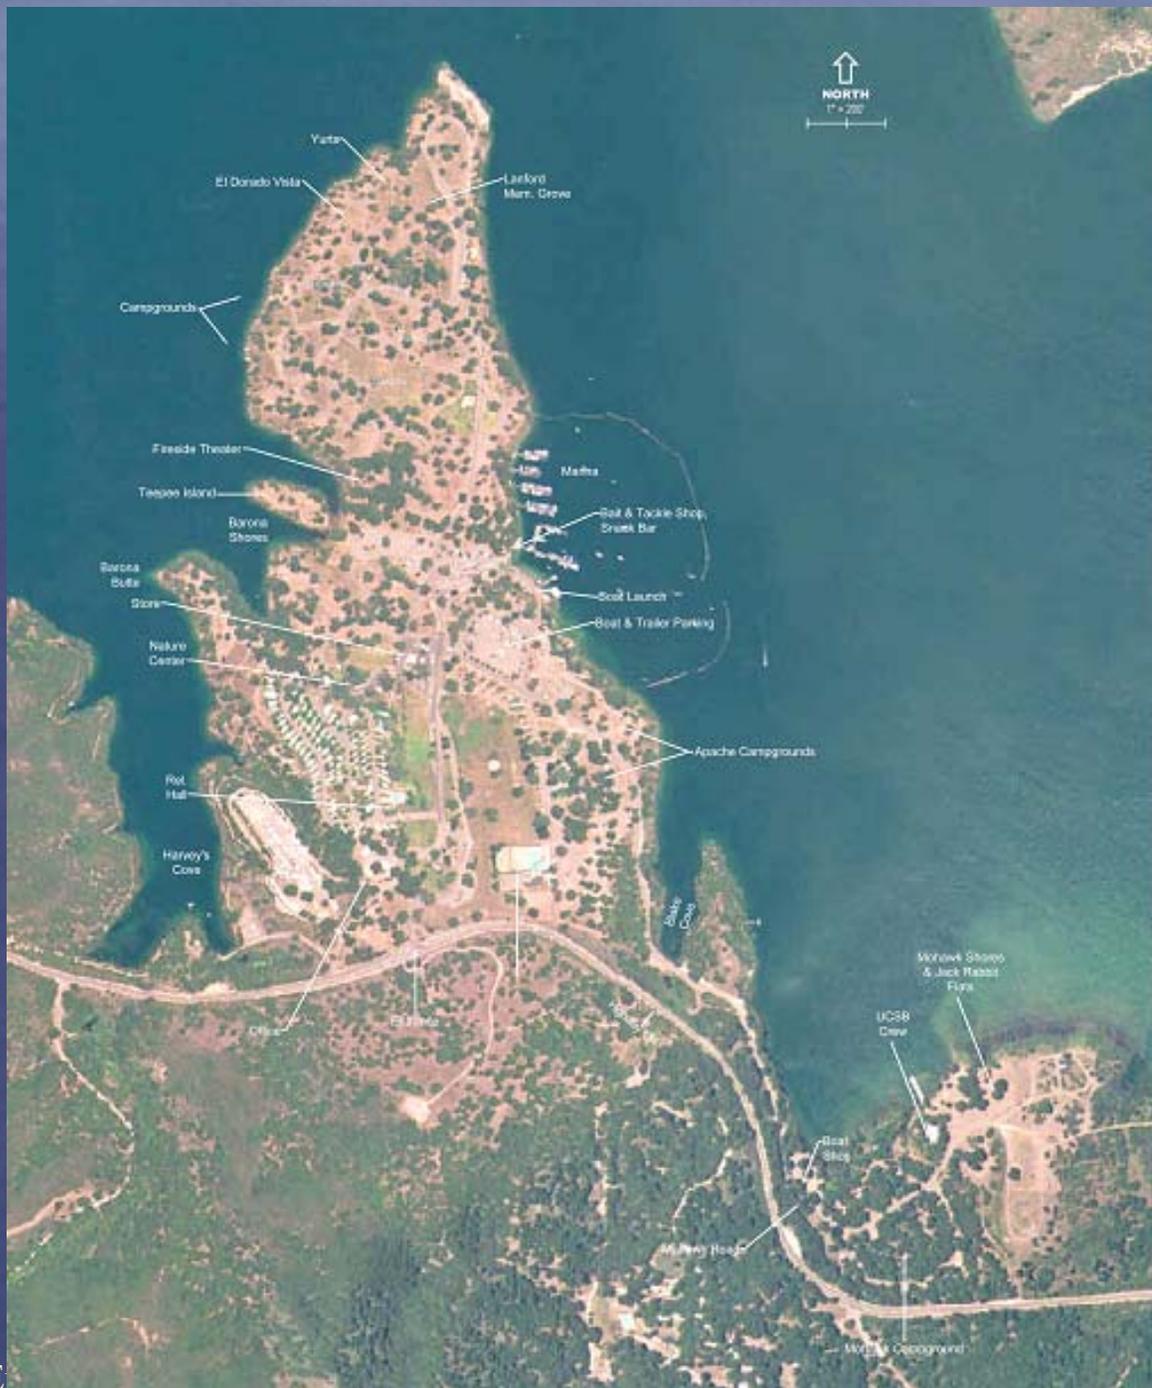
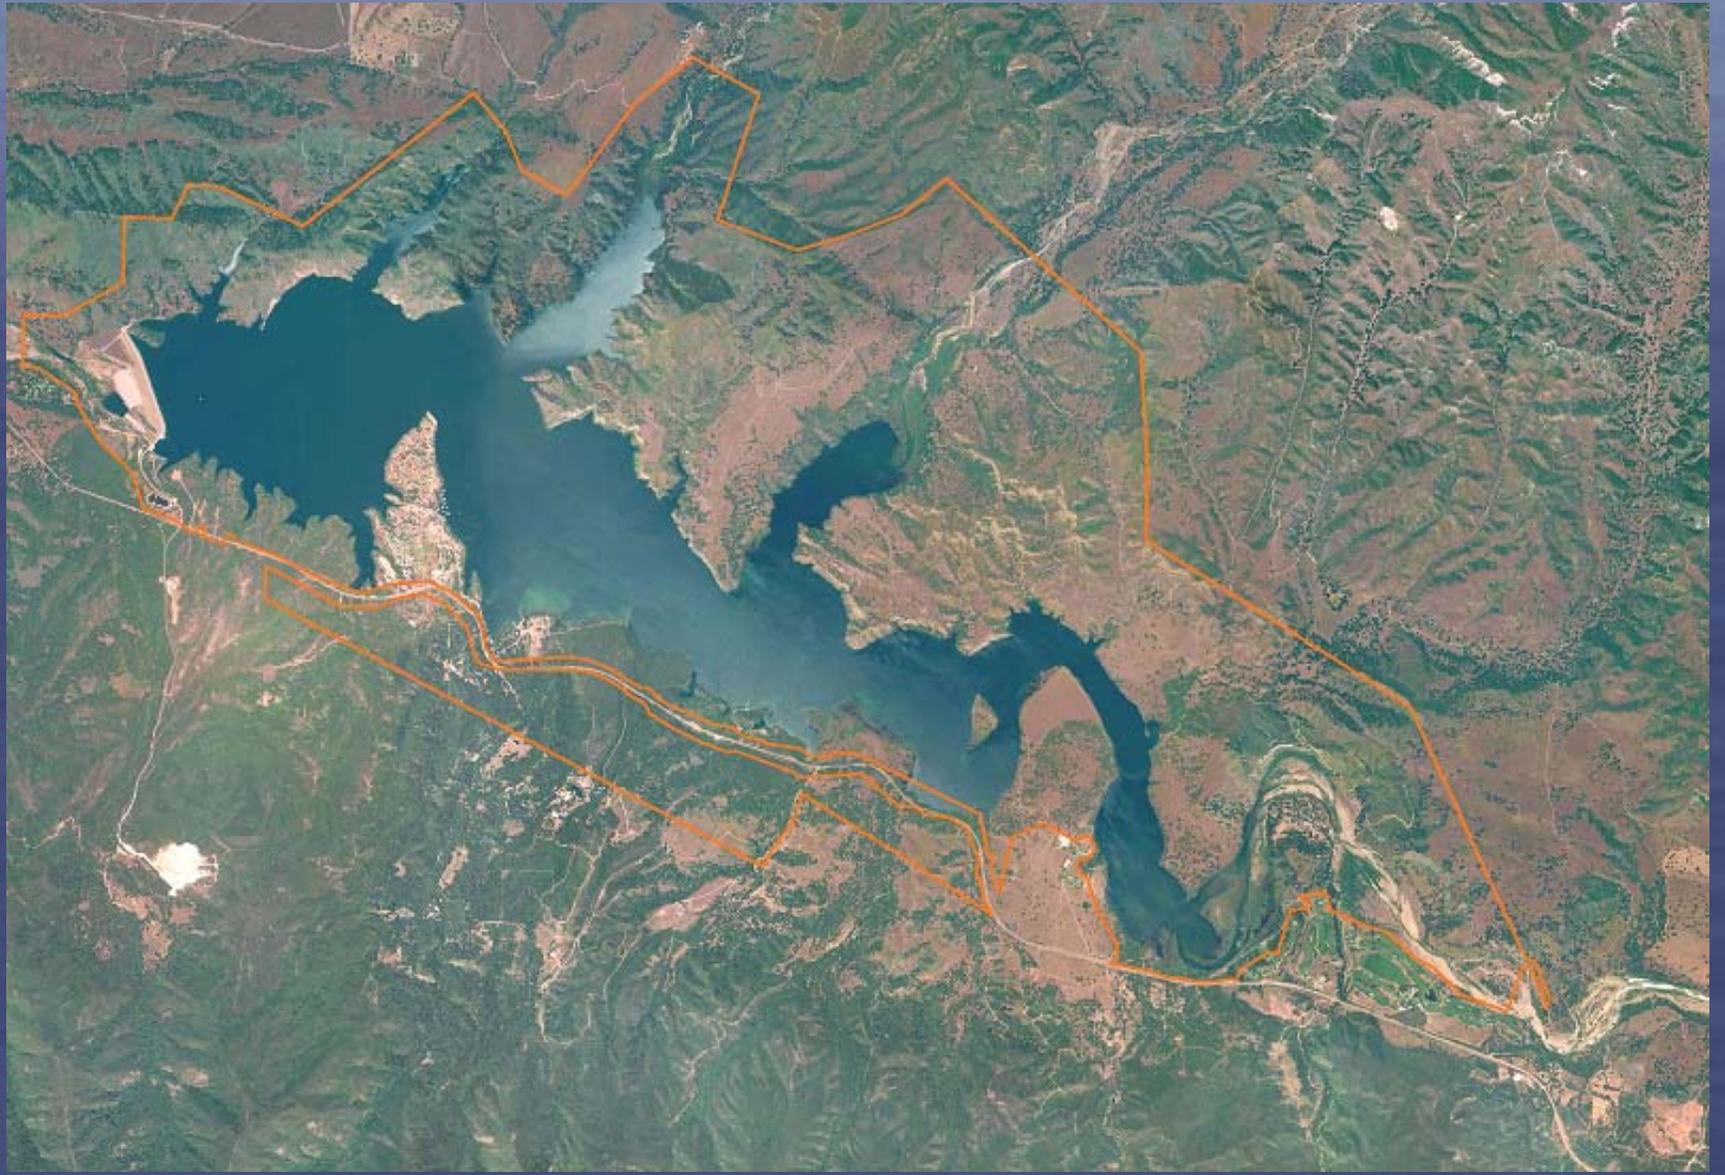
- Primary restoration site is County Park
- Secondary restoration sites: Storke Flats, Santa Ynez Point, Bradbury Dam
- Replacement planting phasing:
 - Plant trees needed to replace $\frac{1}{2}$ of the estimated tree loss (251 trees) immediately
 - Plant trees to replace those observed to be lost over the next 10 years
 - Plant final trees at the end of 10 years

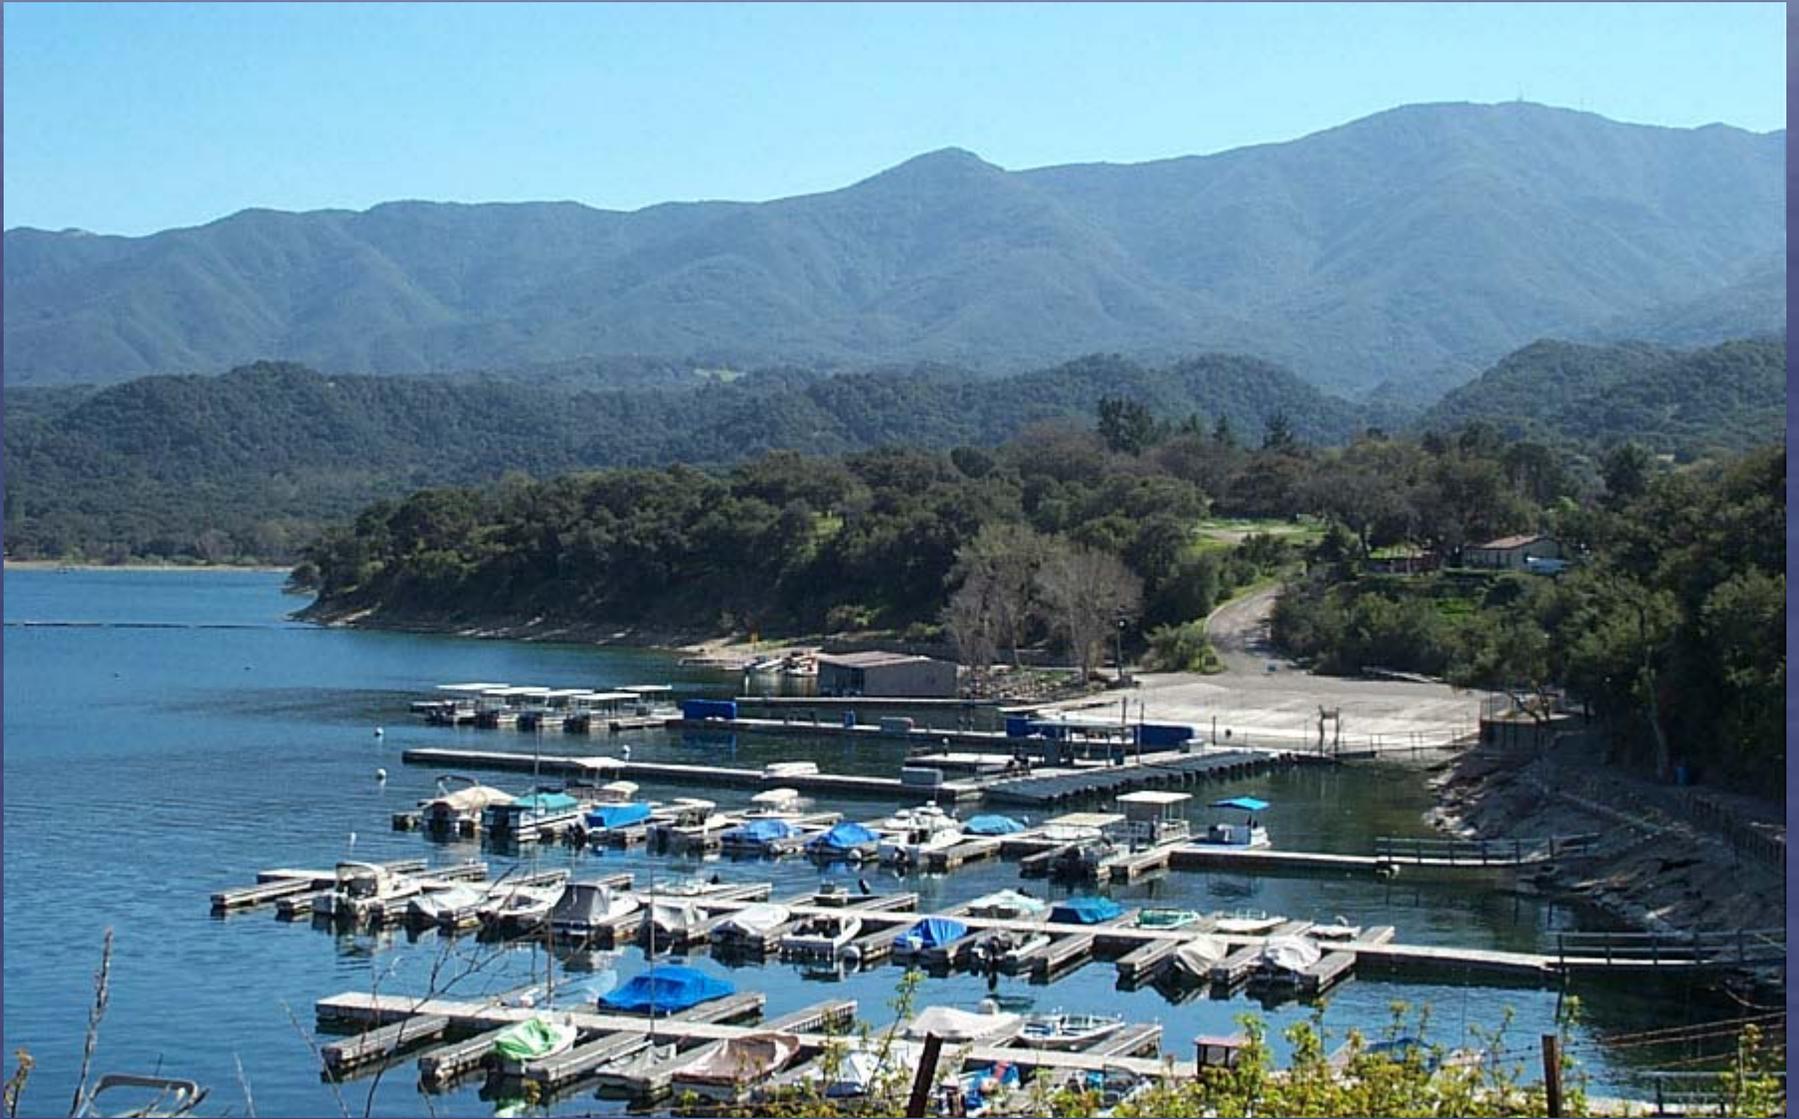
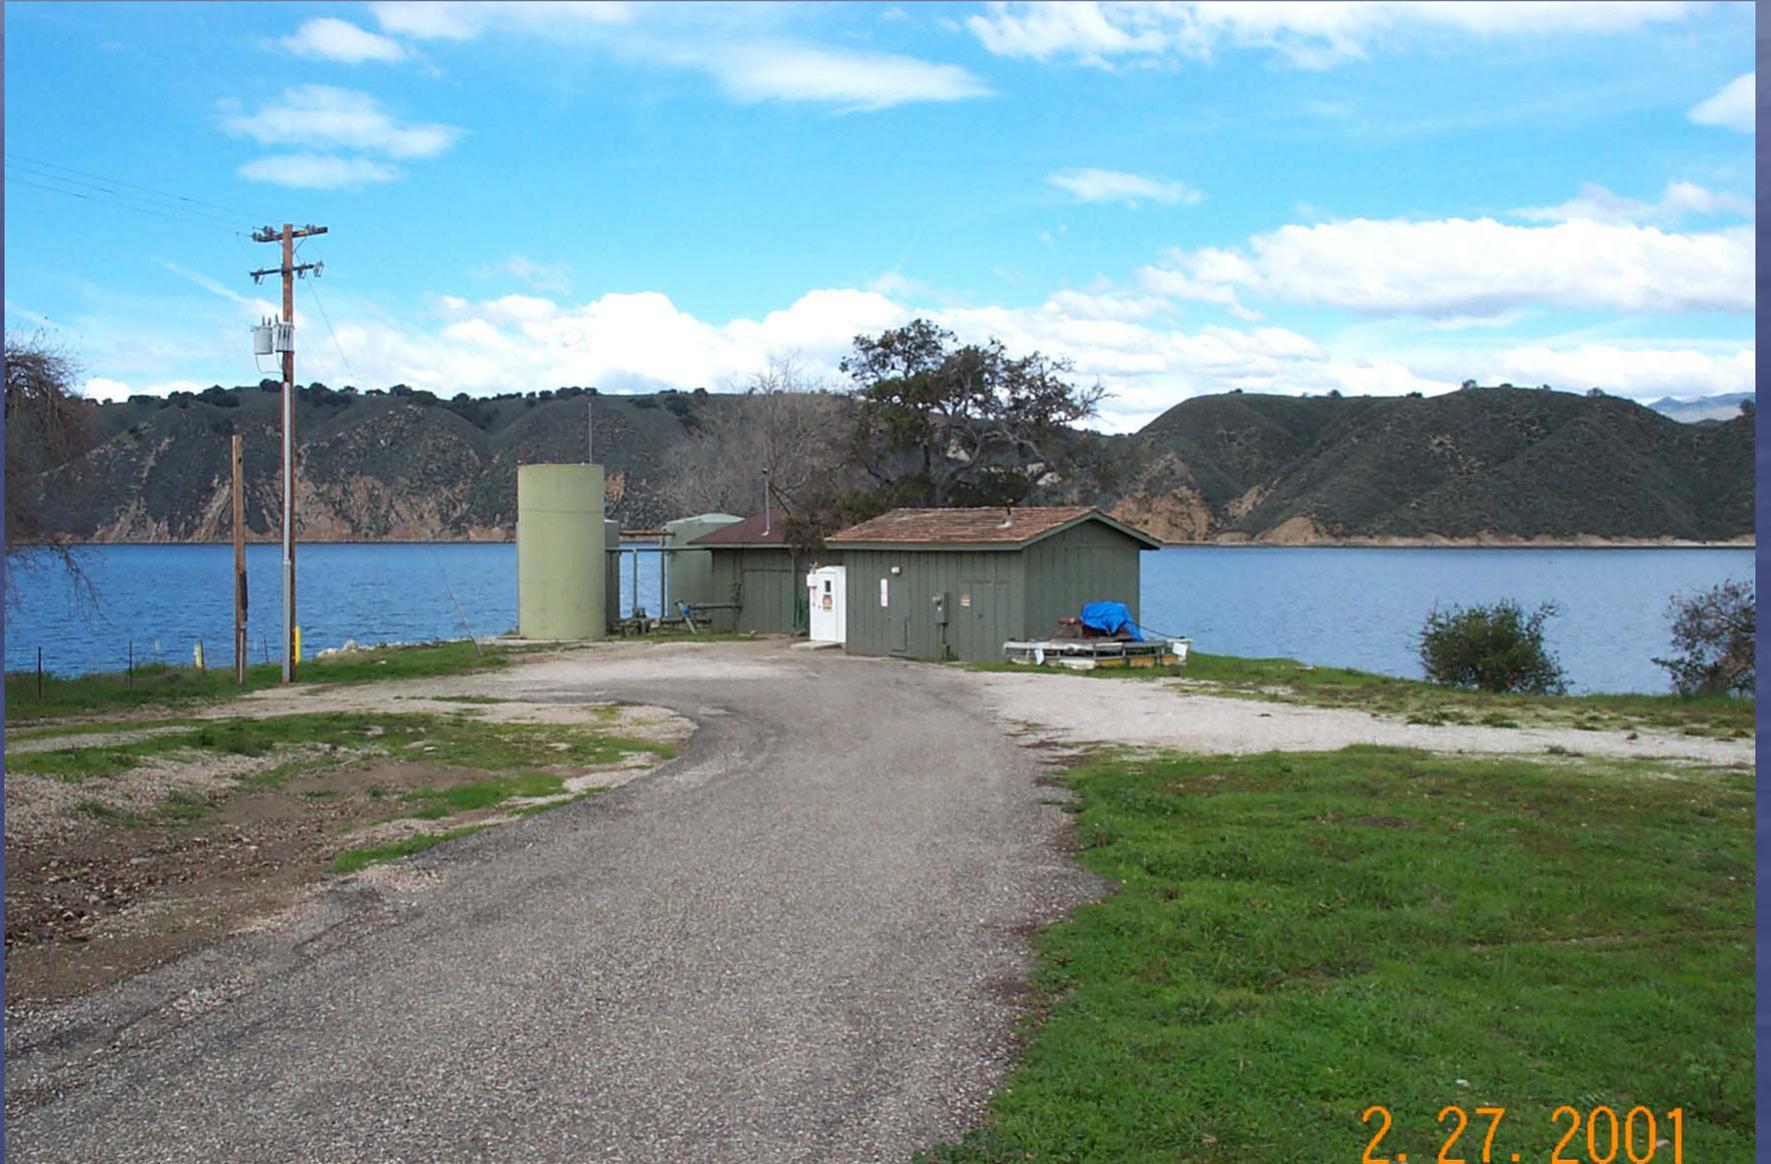
- Critical facilities:
 - Drinking water intake and treatment plant
 - Sewer lift stations
- Key non-critical facilities:
 - Boat launch ramp
 - Marina path and floating docks
 - Marina shops

- To avoid impacts, County must relocate facilities
- Funding is greatest challenge
- County has initiated actions to relocate facilities using State, Reclamation, and County funds:
 - Lift stations
 - Water treatment plant
 - Boat launch
- County, COMB, and Reclamation are exploring phased surcharging to allow time for completion of facility relocation
